# CONCAVE DISC PRODUCT BENCHMARK

The concave disc from GRANIT  
with part number **1800178201966**  
with comparable products from an original equipment  
manufacturer and three other competitors.

TEST REPORT NO. K 743-2021

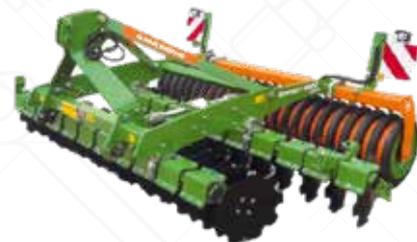
Figure 1: Concave disc for tillage machine/disc harrow

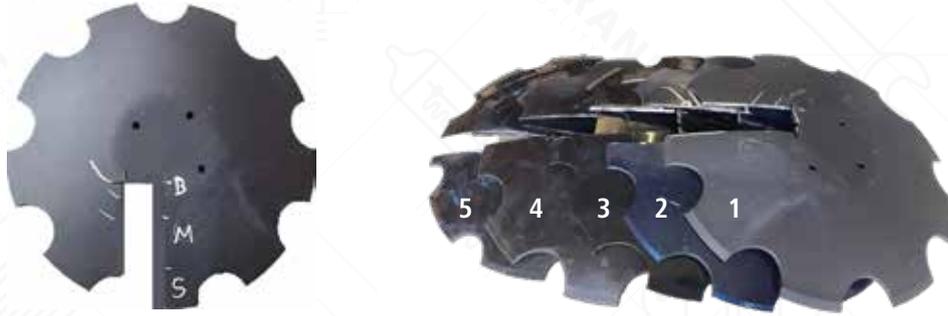
The Vickers hardness test (HV10) was performed in accordance with DIN EN ISO 6507-1:2018. The hardness test was performed on three areas: on the cutting edges (S), the centre (M) and the mounting holes (B). The results were then converted to HRC (in accordance with EN ISO 18265).

Figure 2: Test area and samples taken from the concave discs to be tested.

Supplier	Average values from the areas S, M, B
1	GRANIT	50
2	Competitor 1	50
3	Original equipment manufacturer	51
4	Competitor 2	52
5	Competitor 3	51

All discs were sufficiently hardened at the cutting edge, in the centre and at the holes. These areas must have a certain toughness and strength. Even if the results differ slightly, the differences are only marginal and can be considered negligible. The hardness values are equally good for all the concave discs sampled.

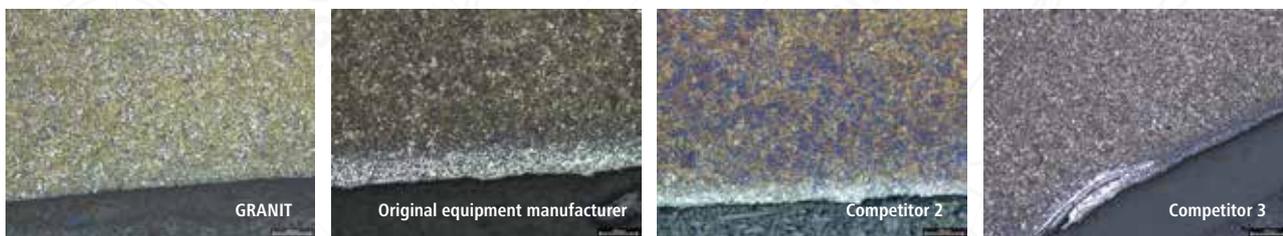
Supplier	Decarburisation at the cutting edge	Comment
GRANIT	None	-
Competitor 1	None	-
Original equipment manufacturer	0.08 mm	Decarburisation more pronounced at the edge, patchy heat influence
Competitor 2	0.05 mm	Decarburisation visible over the entire length, structure shows patchy heat influence
Competitor 3	0.2 mm	Decarburisation more pronounced at the edge

Figure 3: Prepared samples/metal structure. Decarburisation of the cutting edge shown in white.

There was no evidence of blemishes in the structure or decarburisation at the edge of the Granit concave disc. This significantly reduces the susceptibility to wear. This result reflects the optimum process reliability during production.

On the other hand, the discs from the other manufacturers all have blemishes in the structure or decarburisation at the edge. The degree of wear is higher on these concave discs.
